International Conference

**FOREST RESEARCH: a challenge
for an integrated European approach**

PROCEEDINGS

Contribution of log erosion barriers to soil protection and vegetation recovery after wildfire in a *Pinus halepensis* forest, in Greece

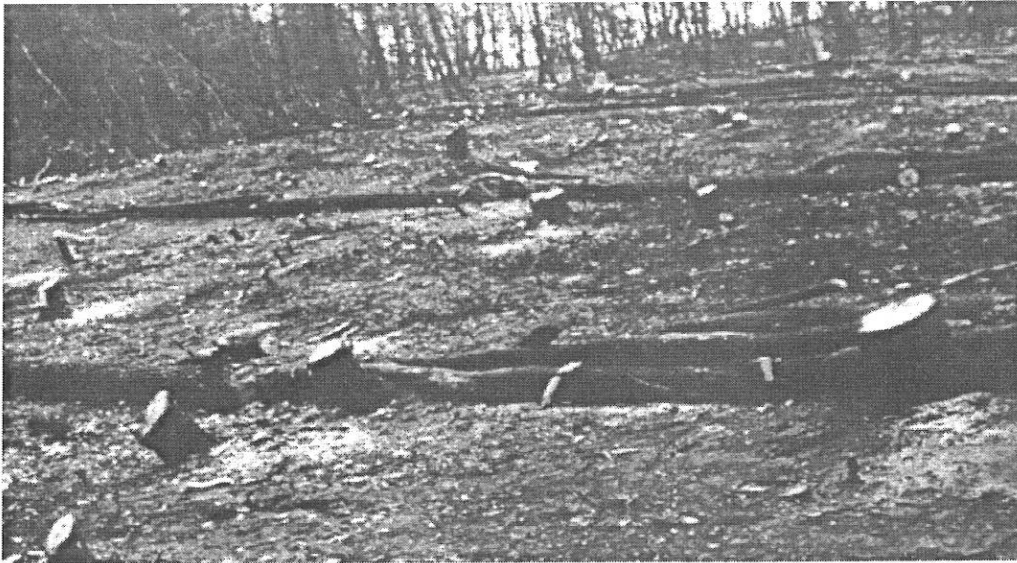
PHOTO 1. Construction of log-erosion barriers using felled burnt pine logs.

As far as the high slope category is concerned, a significant amount of soil erosion (2.23 mm) was measured in the control plot and a significant quantity of deposition (3.44 mm) was collected by the log erosion barriers (Photo 1).

In the high slope category plots, the treatment served its purpose. The log erosion barriers not only stopped soil erosion but also resulted in significant soil deposition behind each log. This effect was very pronounced and contrasts strongly with the significant amount of erosion observed in the high slope control plot.

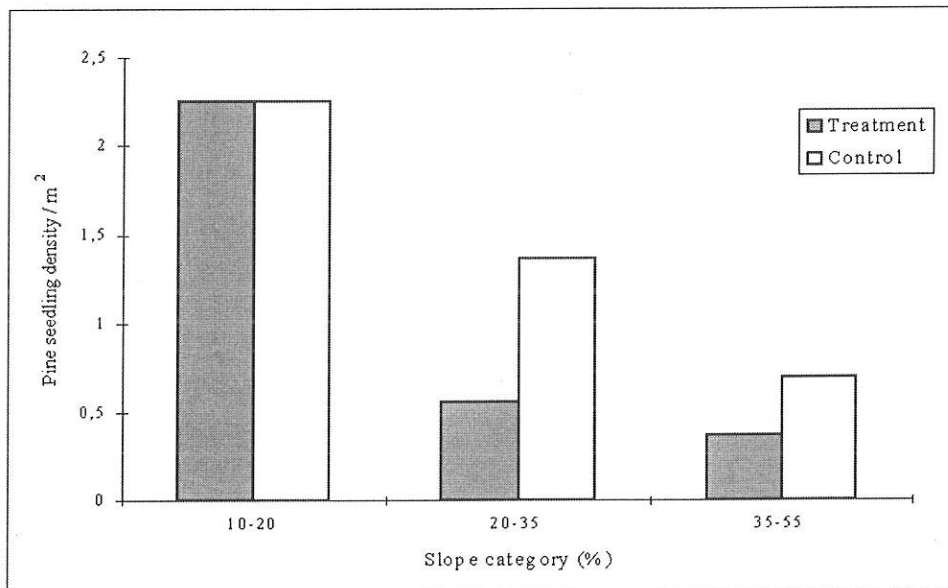
FIGURE 3: Pine seedling density per m² in treated and control plots to the corresponding slope categories

seedlings per m² and it was found in both plots (treated and control) of the low (10-20%) slope category. The smallest density values were measured on the higher slopes (Figure 3).

Although a reduced number of seedlings was observed on the higher slopes and in the treated plots, this difference was statistically significant only in the moderate (20-35%) slope category.

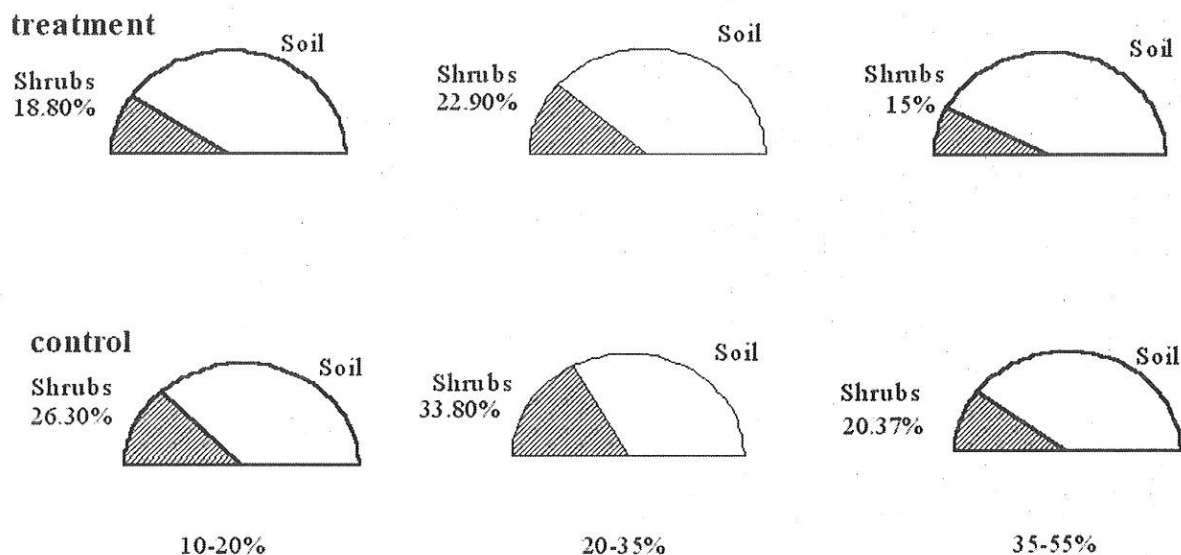
FIGURE 5: Percentage of shrub recovery in the treated and control plots to the corresponding slope categories.

The percentage of shrub recovery was higher in the control plots than in the treated ones, in all slope

categories (Figure 5).

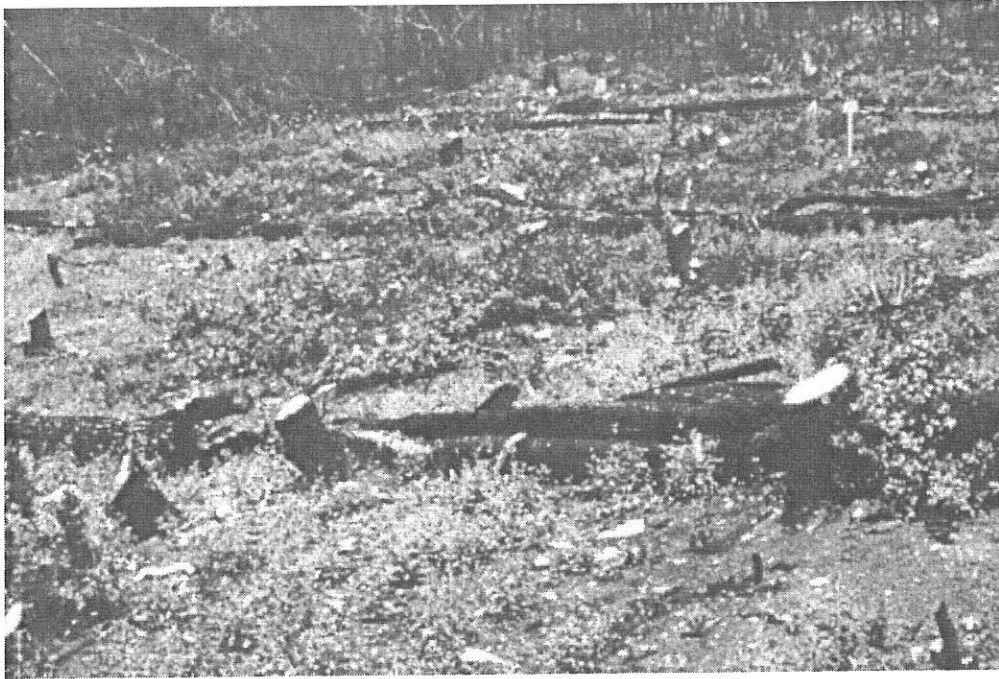
PHOTO 2. Soil deposition and natural regeneration progress, four months after the installation of log-erosion barriers.

The higher percentage (33.8%) was observed in the control plot of the moderate (20-35%) slope category and the smaller one (15%) in the treated plot of the high (35-55%) slope category (Photo 2).
