Proceeding Paper

Soil Optical and Hydraulic Properties of Burnt Forest Areas in Greece after the Implementation of Postfire Restoration Works—Preliminary Results [†]

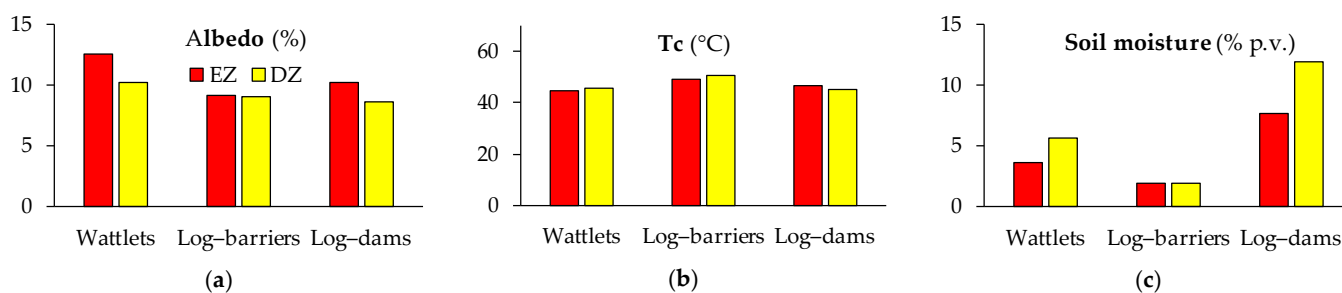
Figure 1. (a) radiation reflectance (albedo), (b) soil surface temperature T_c , and (c) soil moisture at the erosion (EZ) and soil deposition (DZ) zones of different types of restoration works.

In the present study, the reflectance (albedo) of the soil was estimated above the erosion zone (EZ) and the deposition zone (DZ) in the area between consecutive restoration work units. EZ presented slightly higher albedo compared to the DZ (Figure 1a), suggesting that less solar energy is absorbed by the soil in the DZ, regardless of the type of restoration work. Considering the absence of vegetation, the absorbed radiation is used for heating the soil and not effectively for photosynthesis or plant-related processes [10].

On average, $9.2 \pm 3.1\%$ of the incoming solar radiation is reflected in DZ, and the remaining part is absorbed by the soil, whereas the respective percentage for the EZ is slightly higher ($10.4 \pm 2.4\%$). This pattern can be partly associated with the slightly higher water content of the soil in the DZ (soil moisture $6.4 \pm 7.6\%$ p.v., Figure 1c) compared to the EZ ($4.4 \pm 5.7\%$ p.v.), which enhances the absorbance due to the water's ability to store energy. The higher amounts of absorbed radiation in the DZ are consistent with the higher surface temperatures compared to the EZ (Figure 1b). This high heat storage in the DZ could be useful for the natural regeneration of vegetation compared to EZ, especially in spring and autumn. However, the extremely high T_c ($46.5 \pm 11.3^\circ\text{C}$ for EZ and $47.5 \pm 11.8^\circ\text{C}$ for DZ) indicates that in the post-fire environment, especially in summer, vegetation is under thermal stress, and the young seedlings is not likely to survive, considering also the limited water availability during this season. At this stage (the first year after the fire) and under

At the different types of works, albedo differences between EZ and DZ were minor. Albedo for the wattle piles and log dams were slightly higher at the EZ (by +0.024 and +0.016, respectively) compared to DZ, whereas negligible differences were found for the log barriers. Wattles and log barriers presented warmer T_c at the DZ (by -1.06 and -1.5 °C), whereas log dams DZ were cooler (by +1.2 °C) compared to EZ. The high height of log dams probably led to a relatively cooler microenvironment in DZ, which also has higher soil moisture differences (by 4.3%).

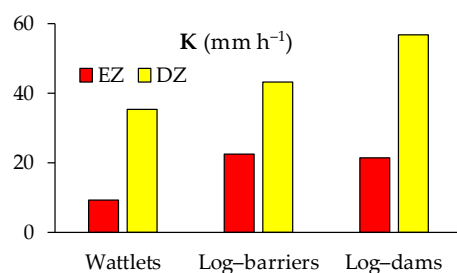
Figure 2. Unsaturated hydraulic conductivity K at the erosion (EZ) and soil deposition (DZ) zones of different types of restoration works.

The positive impact of urgent restoration is more sound when assessing the ability of the burnt soils to infiltrate water (Figure 2). The soil deposited in the DZ presents much higher unsaturated hydraulic conductivity, K values, that exceed by 144% on average the K in the EZ, with respect to the differences between different soil types, regions, and types of restoration works. The average K indicates that EZ soil infiltrates water at a rate of 18.7 ± 16.3 mm h⁻¹, whereas the respective value for DZ is 45.8 ± 35.9 mm h⁻¹. Such high infiltration rates in the DZ minimize the risk of surface runoff that can lead to soil erosion. It should be mentioned, however, that the above-mentioned K values for the DZ present high variability ranging from 22.9 ± 20.1 mm h⁻¹ in the log barriers of Tatoi (Attica), which have sandy loam soils to 75.8 ± 77.8 mm h⁻¹ in the log dams of Ilia (Western Greece) with the sandy loam soils. The K values for the EZ have smaller variability and range from 6.7 ± 6.1 mm h⁻¹ at the sandy loam soils of the wattles in Ilia to 26.7 ± 23.6 mm h⁻¹ to the log barriers of Corinth (Peloponnese), which have clay loam, loam, and sandy loam soils. It is evident, though, that in all cases, the DZ can infiltrate higher water amounts compared to the EZ, and this suggests that the application of urgent restoration works surely protects the ecosystem from further degradation, limiting the risk of water erosion. The new vegetation is expected to favor infiltration since the hydraulic conductivity is positively affected by the forest canopy cover [11]. As plants grow deeper roots, the soil matrix will develop stable pathways for the movement of water that will increase the soil's hydraulic conductivity [12–14], which is also related to the preferential flow of the soil water around the roots [15]. Thus, it is extremely important to accelerate vegetation growth in burned ecosystems via restoration and also provide the appropriate time for the full ecosystem recovery.
